Monthly Oversight Report 58
44728 AES [46526 RAC]
ACS NPL Site
Griffith, Indiana
October 1, 2005 – November 4, 2005

Subject: Monthly Oversight Summary Report
No. 58 for October 2005

Monthly Oversight Summary Report No. 58
ACS Superfund Site
TO 057, 44728.238 (AES) [WA57, 46526.238 (RAC)]

Reporting Period: Month of October (October 1, 2005 – November 4, 2005)

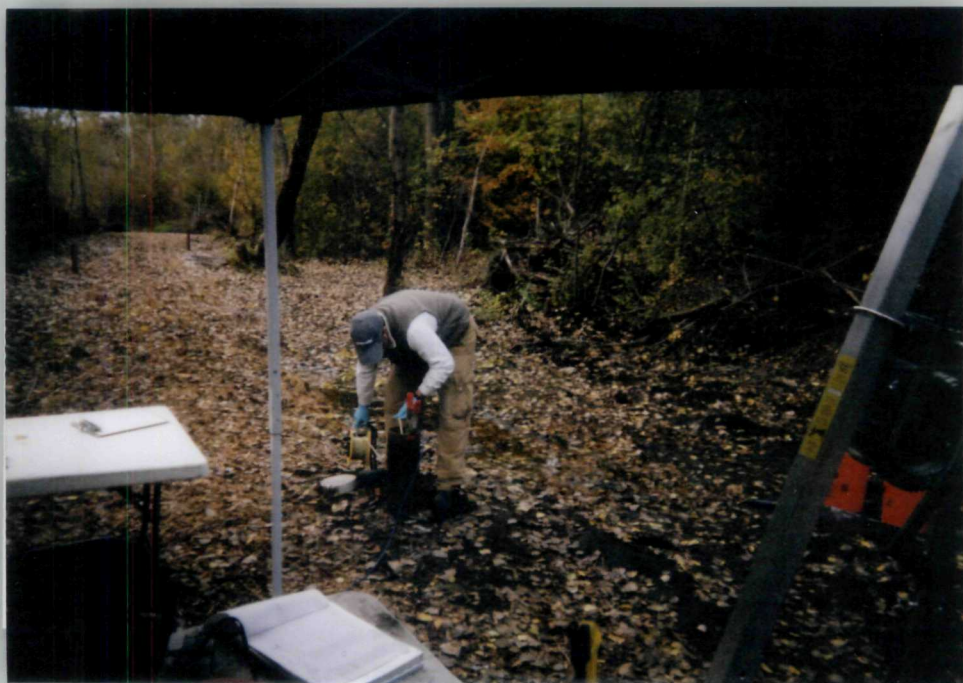
Site: American Chemical Service, Inc.
 Proj. #: 44728 AES [46526 RAC]
 Roll: 81 Photo #1
 Date: 11-01-05 Time: 1600
 Photographer: Larry Campbell
 Description: Photo facing west showing Dave Powers
 taking hourly water level reading at MW53.

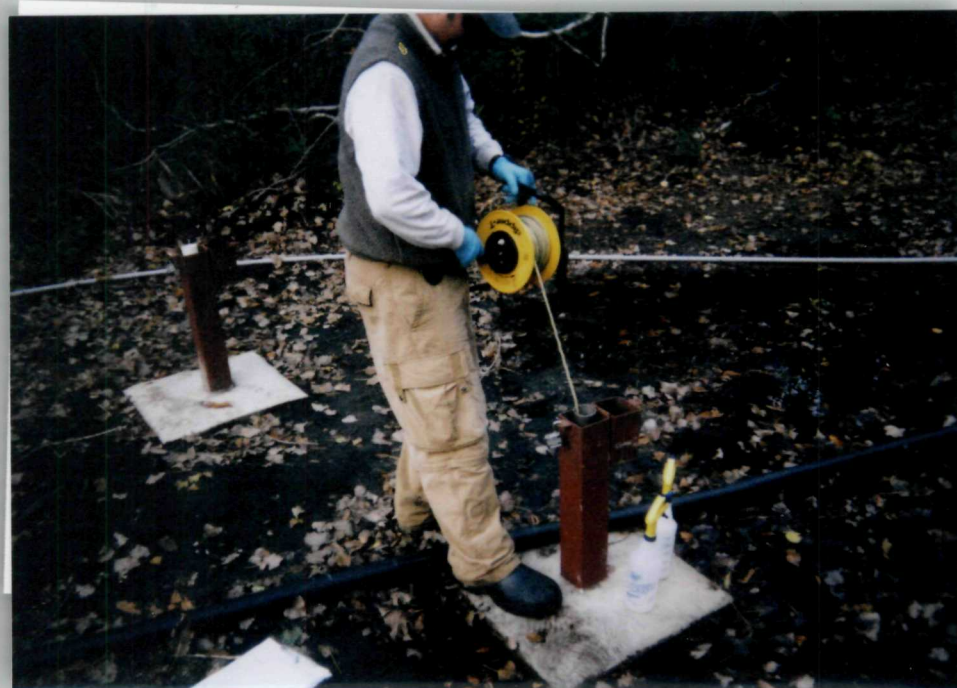
Site: American Chemical Service, Inc.
 Proj. #: 44728 AES [46526 RAC]
 Roll: 81 Photo #2
 Date: 11-01-05 Time: 1604
 Photographer: Larry Campbell
 Description: Photo facing north showing Dave Powers
 measuring water level in MW57.

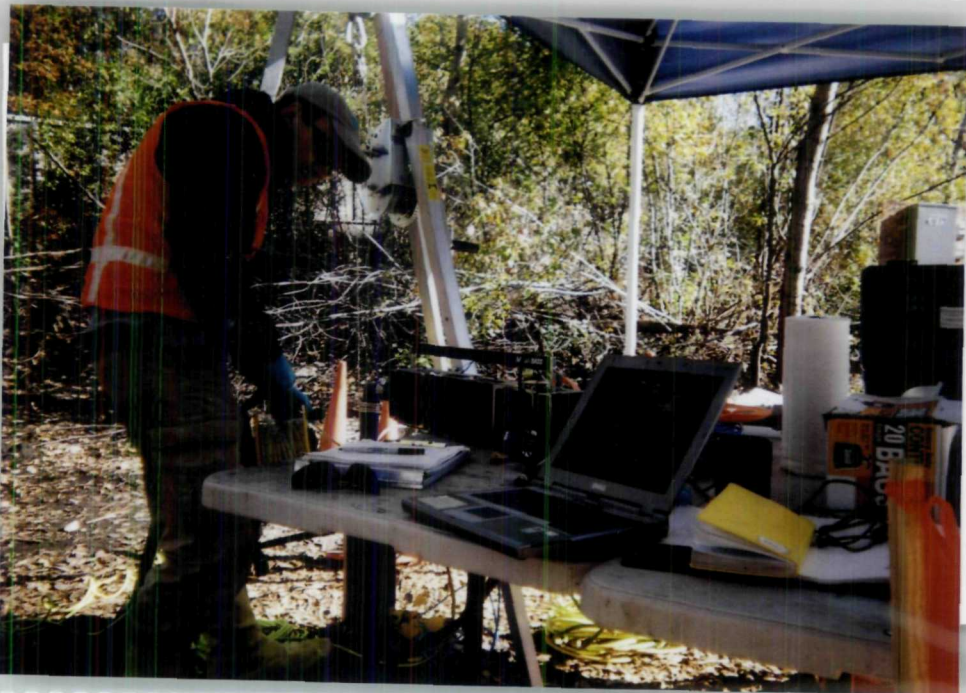
Description: Photo facing northeast showing MWH taking water level reading at EW02. Pumping at 20 gpm. Drawdown in EW02 is approximately 7 feet.

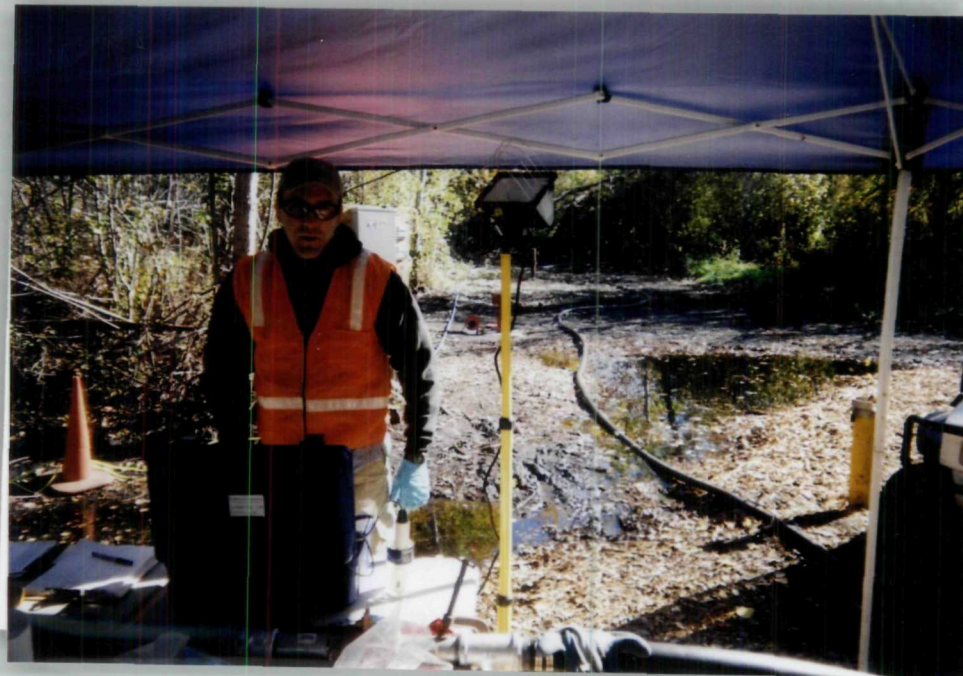
Description: Photo facing east showing Chad Smith measuring groundwater parameters.

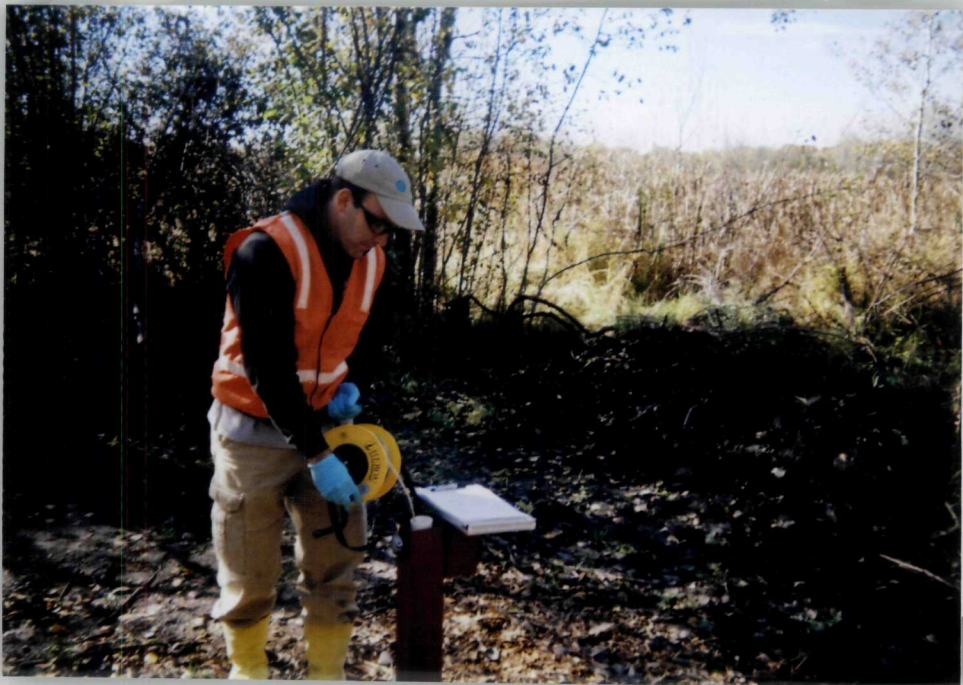
Site: American Chemical Service, Inc.
Proj. #: 44728 AES [46526 RAC]
Roll: 81 Photo #5
Date: 11-02-05 Time: 1010
Photographer: Chad Gailey
Description: Photo facing southwest showing Chad Smith
taking water level readings at LA15.
